Report No. CG-D-42-95

Evaluation of Innovative Vessel Inspection Techniques (Phase II, Advanced Technology)

**FINAL REPORT
JULY 1995**

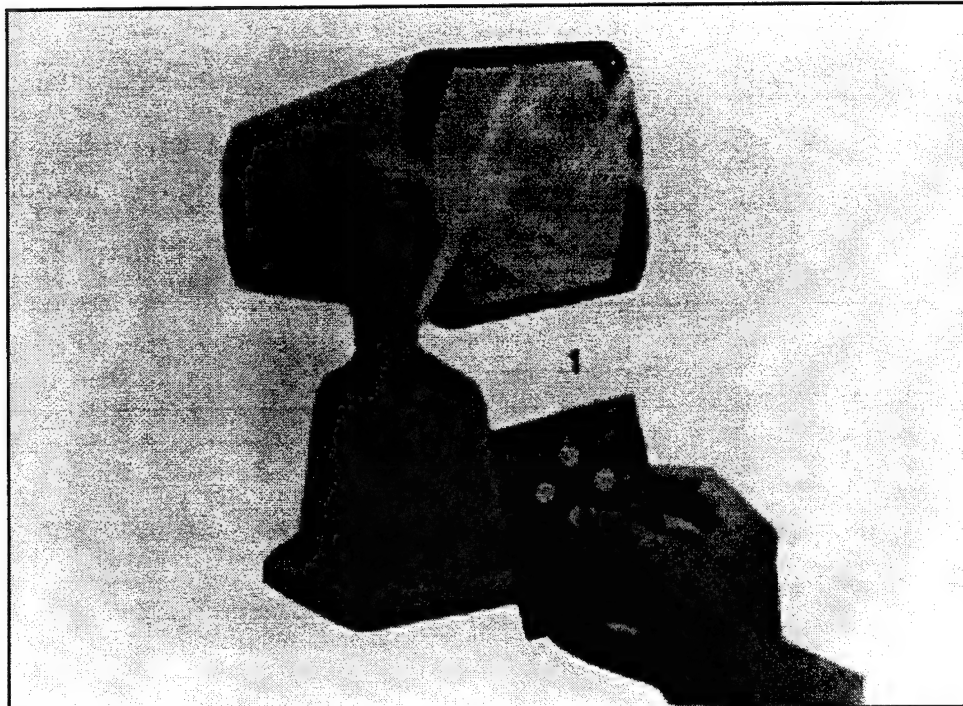
Figure 1 Guest Beamer Remotely Controlled Light

A light which could be hung from a tank-cleaning opening, powered from a deck-based power source, and controlled remotely by an inspector at the tank bottom would offer two major advantages. First, the inspector would not have to carry the light to the bottom of the tank and back. Second, the distance from the light to the area being illuminated would be shorter, thus providing more light intensity at the target for a given amount of lighting power.

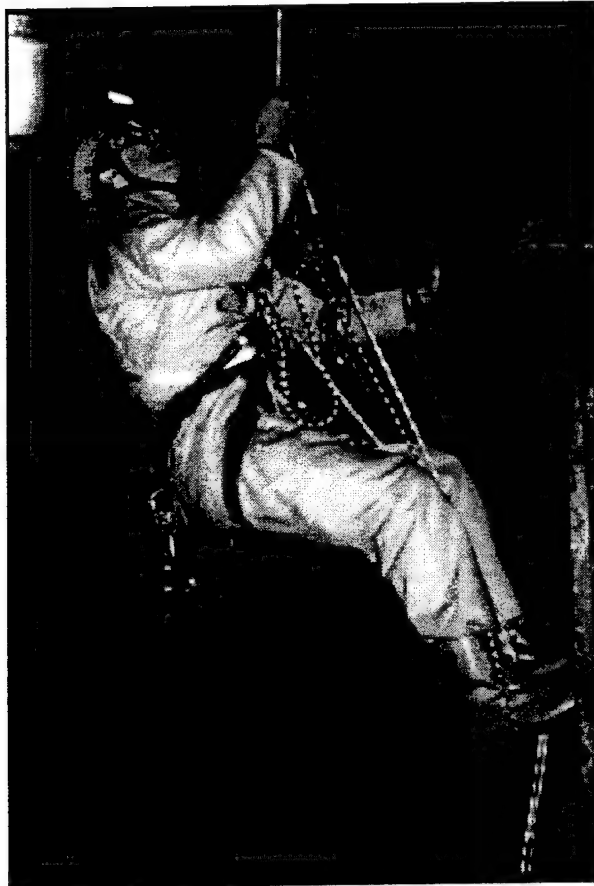
Figure 4 Climbing Inspector (View 1)

Climbing inspectors can be used to inspect anywhere where a "safe for entry" condition exists. They are particularly useful for inspecting the overhead and high on the bulkheads of large tanks where staging costs would be very high. By using mountain climbing equipment, the effort involved in setting-up and breaking-down staging or rafting is averted. The climbing inspector is also able to perform portable non-destructive tests and some repairs while at the inspection area.

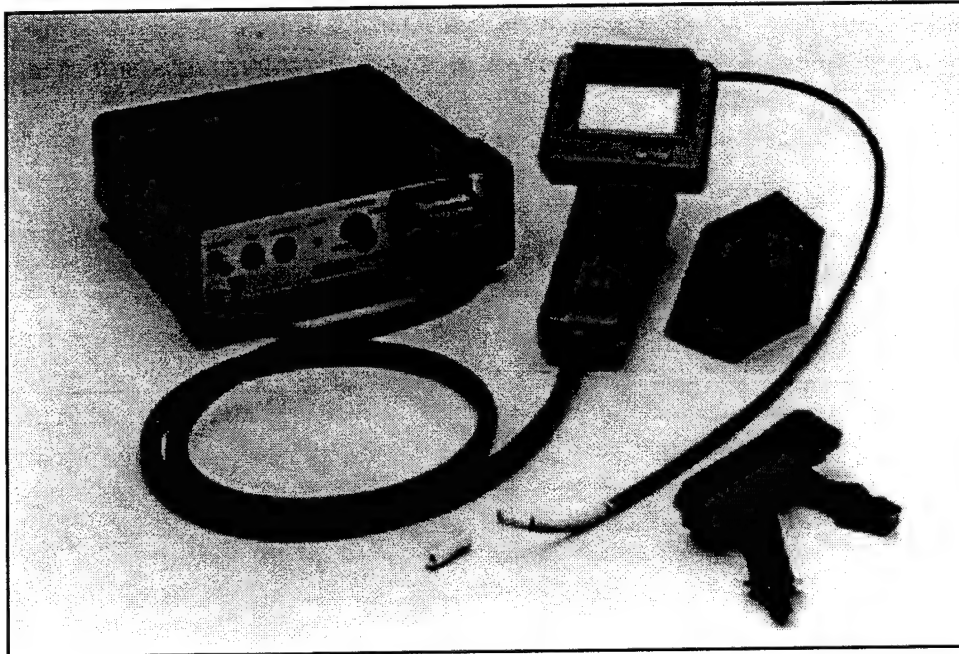
Figure 8 Welch Allyn Video Probe XL

Locations in the fire room and engine room were used to conduct a demonstration of the Welch Allen Video Probe XL, Figure 8, scope first demonstrated at the Coast Guard R&D Center. This scope was lowered into the test void but proved to be totally ineffective for use in a large space. Several locations in the fire room were inspected including the mud drum of one main boiler, a burner opening, and a main feed pump discharge line. Several other interesting locations in the fire room and engine room were located but a working electrical outlet was not available in the vicinity to plug in the scope.

Video scopes were demonstrated in a laboratory situation and also on board ship in the engine and fire rooms. Several systems from Welch Allyn and Olympus America were demonstrated. All these work very well for close-up viewing of small areas and might have some applicability for viewing local areas behind inaccessible stiffeners or the insides of tubes. None worked very well for viewing surfaces at 18 inches or more from the probe tip. The lighting supplied by the fiber optics was the major factor in this. Both companies have larger size systems with probes of 0.5 inch diameter or more. They claim these systems provide sufficient light to view objects up to two feet away. Such systems were not demonstrated, however. If video scopes are to be useful for inspecting boiler drums or air flasks, a viewing distance of at least two feet is essential. The larger, heavier video scopes will be more of a problem to move around in the ship. The larger systems demonstrated were already difficult to transport easily.

Video scopes do give an excellent display of objects within their field of view. It is likely that the larger systems would do even better. One other problem with video probes is the difficulty with orientation of the probe to the object being viewed. Unless some landmark on the object is visible it is easy to lose track of where you are. You may find defects but not know where they are located.
